Customer experience: Yaskawa SGMPH-04DAA21D motors

Procurement of 10 Yaskawa SGMPH-04DAA21D motors

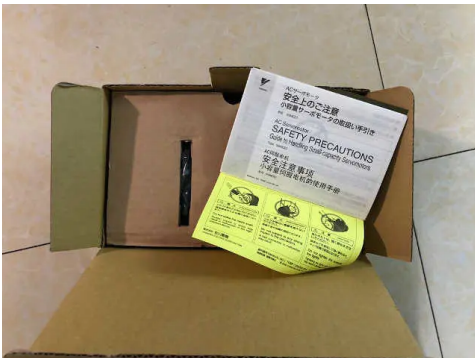
At first glance, everything seems fine.

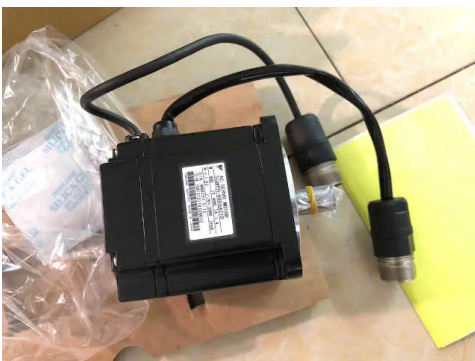
Even the type designation has been adjusted to 400V.

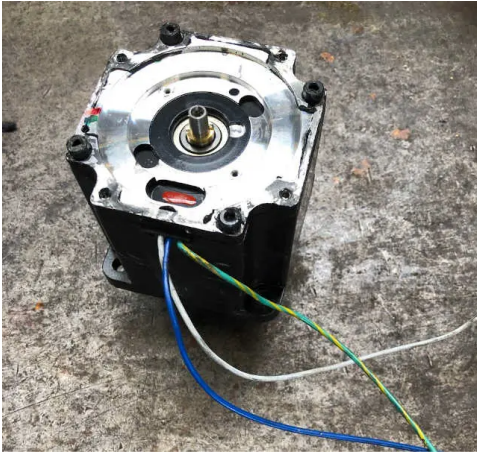
The motors basically worked, but our technicians immediately noticed unusual noises. We disassembled

some models and it turned out that the noises were caused by a worn ball bearing.

We had already anticipated that there would be potential problems with this model and accordingly equipped the spare parts warehouse with encoders and new ball bearings.

The motors were then all overhauled, cleaned as well as painted and delivered to the customer. After about 2 weeks, the customer contacted us with a serious problem. He had tried to put the motors into operation, but he could not connect them mechanically. As a result, the customer compared the power connectors with originals and found that they did not match. Consequently, our technicians measured and documented an original motor with 200V and 400V, as well as the winding resistance of the UVW phases. The winding resistance for an original 200V version motor is approximately $3 \times 2.0R$ and for 400V motors is approximately $3 \times 7.5R$. It turned out that the motors from the Asian dealer, who stated in the type designation that they would be 400V motors, were only 200V motors. In our customers case, everything was original and at this point we realized that we may have been victims of fraud. Our customer returned the goods.

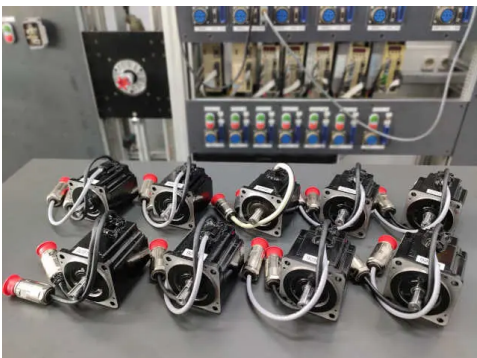
Measurably, the winding resistance of the UVW phases gave different values compared to an original motor.

If the customer continued to try to keep the motors in use, consequential damage would be inevitable. The winding of the motors had a much lower resistance value than originally specified. This could overload the servo amplifier and, in the worst case, cause it to fail due to overheating or start fires on neighboring components.
